USAAVLABS TECHNICAL REPORT 70-55

APPLICATION OF COMPOSITE MATERIALS TO AN AIRCRAFT WING SECTION

**U. S. ARMY AVIATION MATERIEL LABORATORIES
FORT EUSTIS, VIRGINIA**

**CONTRACT DA 44-177-AMC-407(T)
GOODYEAR AEROSPACE CORPORATION
AKRON, OHIO**

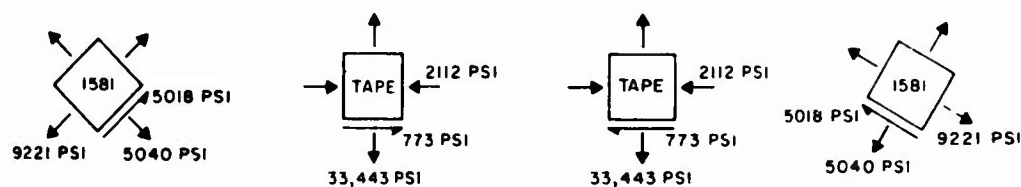
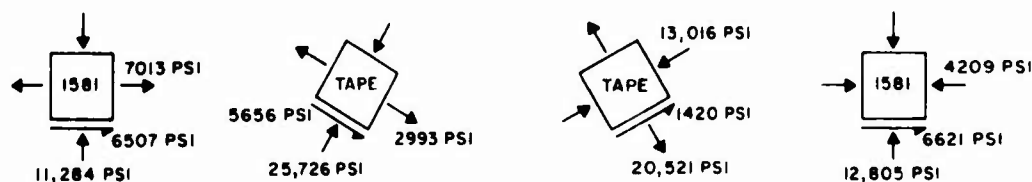
Figure 57. Calculated Stresses in Individual Plies of No. 3 Wing.

$$E_{11} = 4.45 \times 10^6 \text{ PSI} \quad E_{22} = 4.49 \times 10^6 \text{ PSI} \quad G = 1.29 \times 10^6 \text{ PSI} \quad \mu_{12} = 0.420 \quad \mu_{21} = 0.235$$

$$E_{11} = 4.02 \times 10^6 \text{ PSI} \quad E_{22} = 3.19 \times 10^6 \text{ PSI} \quad G = 1.17 \times 10^6 \text{ PSI} \quad \mu_{12} = 0.295 \quad \mu_{21} = 0.234$$

$$E_{11} = 4.07 \times 10^6 \text{ PSI} \quad E_{22} = 3.16 \times 10^6 \text{ PSI} \quad G = 1.16 \times 10^6 \text{ PSI} \quad \mu_{12} = 0.300 \quad \mu_{21} = 0.233$$

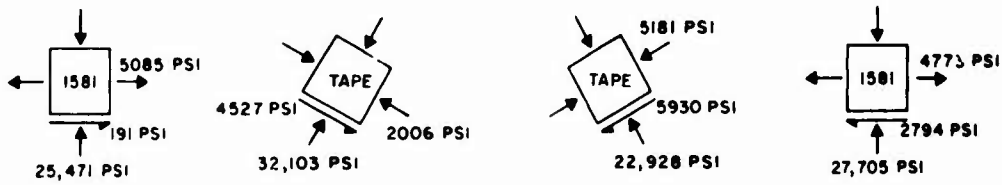
UPPER SKIN - LOAD CONDITION II

The stresses in the individual plies for these conditions were calculated by using the GAC computer program for the analysis of orthotropic laminates. These stresses are shown in Figure 57.
